Manhole Inspection Summary

Manhole # S37Y1_011MH

Insp Date: **11/29/07 8:45 AM**

Location Address: **3814 3rd St**

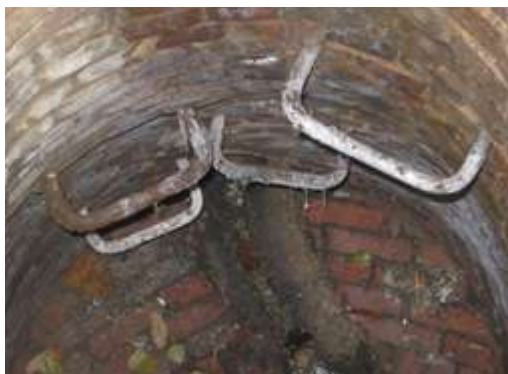
Steps Count: **4** Missing: **0** ☒ **Corroded**

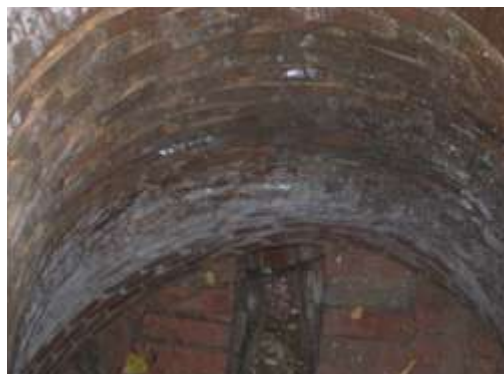
Defect 2

Infiltration: ☐ None ☐ Joint ☐ Cracks ☐ Mortar ☐ Roots ☒ **Wall**

Wall infiltration

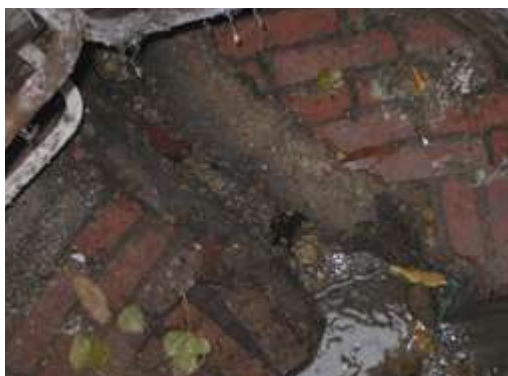
Defect 1

Condition: ☐ Sound ☒ **Cracked** ☐ Root Intrusion ☐ Deteriorated ☐ Leaks ☐ Debris

Bench cracked

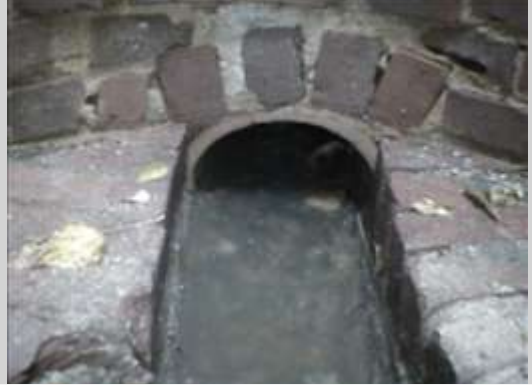
12 O'Clock Outflow

8 in. Circular Gravity Sewer
Pipe Out @ 12 O'Clock

Pipe Height: **10.8** (in.) Rod and Bar (Angled)
Pipe Material: **Clay** ☐ Pipe Lined
Invert Depth: **7.98** (ft.) Flow Characteristics: **Slow**
Deposits: ☒ None ☐ Mud ☐ Sludge ☐ Debris ☐ Grease
Silt Depth: (in.) Deposits Extent:
Infiltration: **None** Pipe Seal Cond: **Sound**

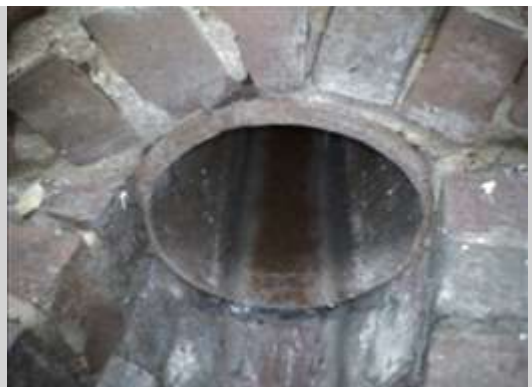
4 O'Clock Inflow

8 in. Circular Gravity Sewer
Pipe In @ 4 O'Clock

Pipe Height: **9.6** (in.) Rod and Bar (Angled)
Pipe Material: **Clay** ☐ Pipe Lined
Invert Depth: **7.41** (ft.) Flow Characteristics: **Fast**
Deposits: ☒ None ☐ Mud ☐ Sludge ☐ Debris ☐ Grease
Silt Depth: (in.) Deposits Extent:
Infiltration: **None** Pipe Seal Cond: **Sound**

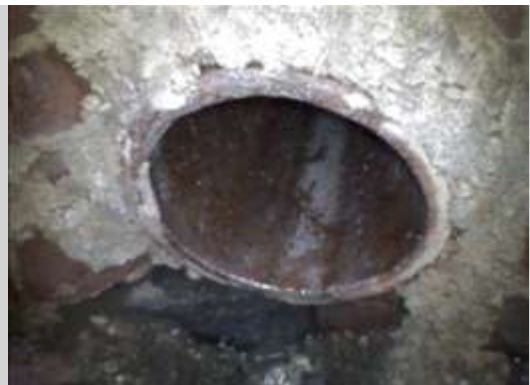
8 O'Clock Inflow

6 in. Circular Service Sewer
Pipe In @ 8 O'Clock

Pipe Height: **8.4** (in.) Rod and Bar (Angled)

Pipe Material: **Clay** ☐ Pipe Lined

Invert Depth: **6.79** (ft.) Flow Characteristics: **Slow**

Infiltration: **None**

Pipe Seal Cond: **Sound**
